Rotax 912 Bed Mount Steel Bracket E1-1X June 24, 2010

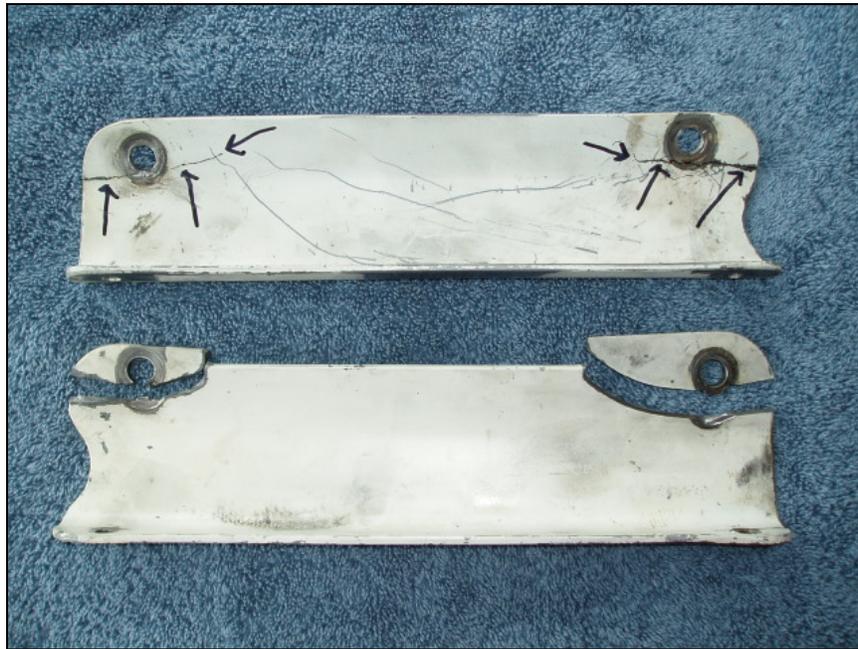
Above: Cracked Rotax 912 Bed Mount Steel Bracket E1-1X

We have had reports of the earlier Rotax 912 Bed Mount Steel Brackets, P/N E1-1X, cracking around the bolt holes that mounts the Steel Brackets to the engine. This has been found on a few earlier Rotax 912 ULS engine installations and is likely caused by the higher vibrations from the 100 horsepower engine along with the rough startup and shutdown of earlier Rotax 912 ULS engines. There are several additional possible causes, including part misalignment or improper bolt torque. A change was made from mild steel to 4130, with the thickness remaining 1/8", a number of years ago to prevent the parts from cracking, and to our knowledge only the mild steel brackets have shown cracking. We need to remind all our builders, owners and operators to inspect these parts thoroughly for cracks and replace them if any cracks are found. Note that the bracket E1-1X is used with Rotax 912 series mounting on different models, including the Zodiac CH 601 and STOL CH 701 series aircraft.

On the last flight before this year's Annual, the passenger side Engine Plate Mount broke out at both bolt holes that fasten the Mount Plates to the side of the 912 Block. The other side Plate had long cracks and could also have failed (at which time the engine could have departed the airframe!). Early engine Frame Plates were constructed of Mild Steel, as were mine. The later Models and replacement Plates are 4130 Chrom-Moly Steel. A second plane in this area was inspected and also found to have cracks, starting at 194 hours.

*Because it is the Pilot/Mechanic's responsibility to watch for and repair these problems, I urge **ALL** to inspect these plates **frequently!** They are difficult to see, and must be inspected with a Flex Mirror, to be absolutely sure of their condition. I encourage anyone with Questions to contact me: Bob Jones, (907) 892-7369, and to study the (above) photo.*
