SERVICE LETTER / NOTIFICATION – July 28, 2020

Control surface clearances

All aircraft – CH designs

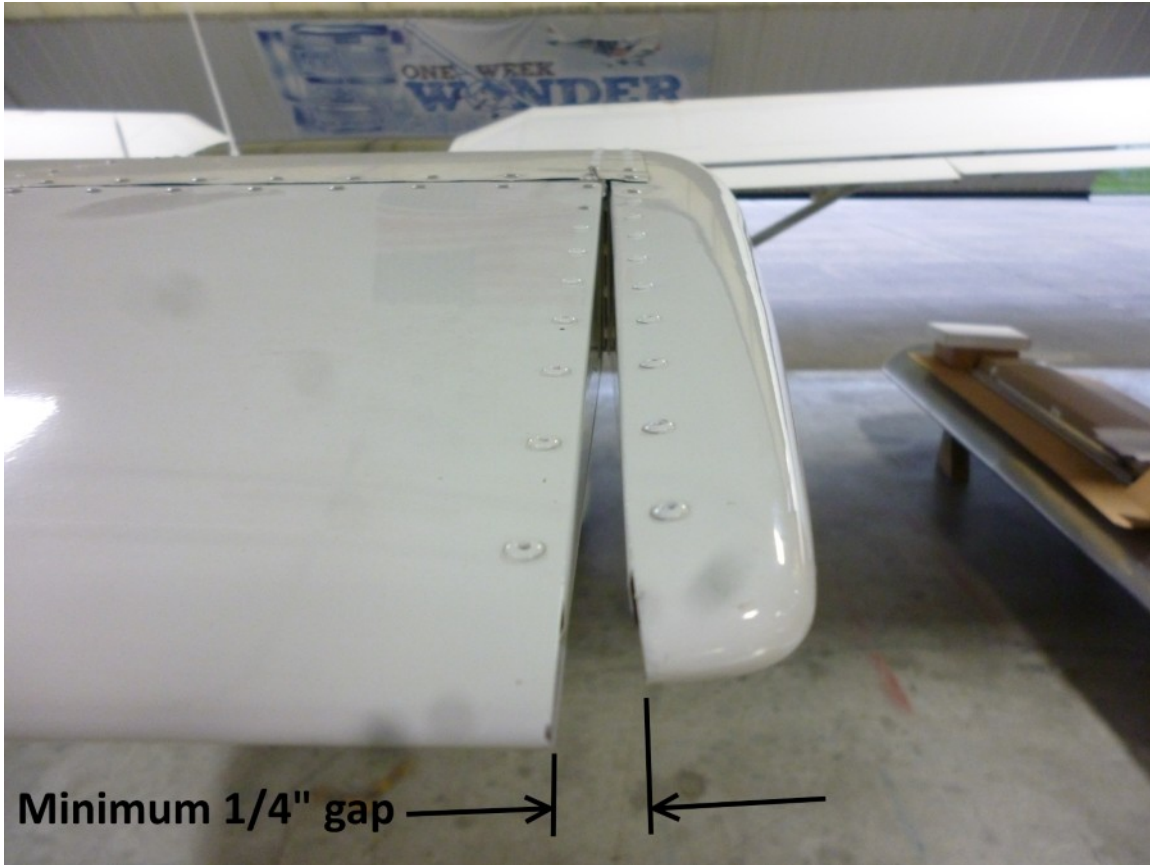
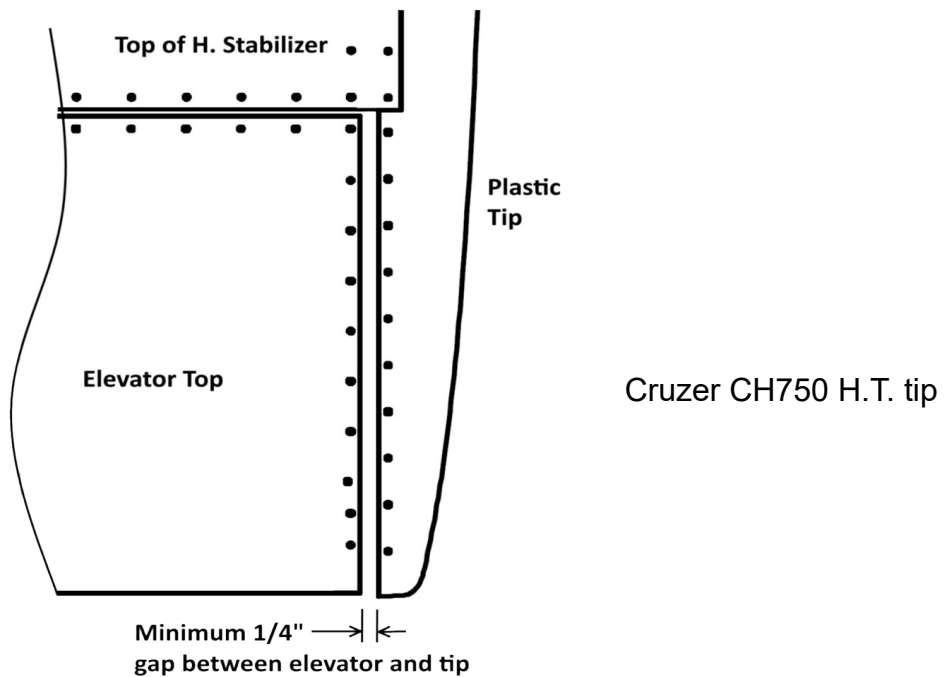
A Zenith Aircraft customer reported that his Cruiser – CH750 elevator was interfering with the tip rib. “I chose to leave a very small gap, and now due to a slight expansion, the plastic tip rib rubs on one side of the elevator. If I would have left a 'normal' size gap, it would be a non-issue”.

“For my fix, I chose to drill out the rivets from the aft edge of the stab back towards the tip. Then I moved the rib over slightly and drilled new holes. Then just trimmed the edge of the plastic tip to make a larger gap”.

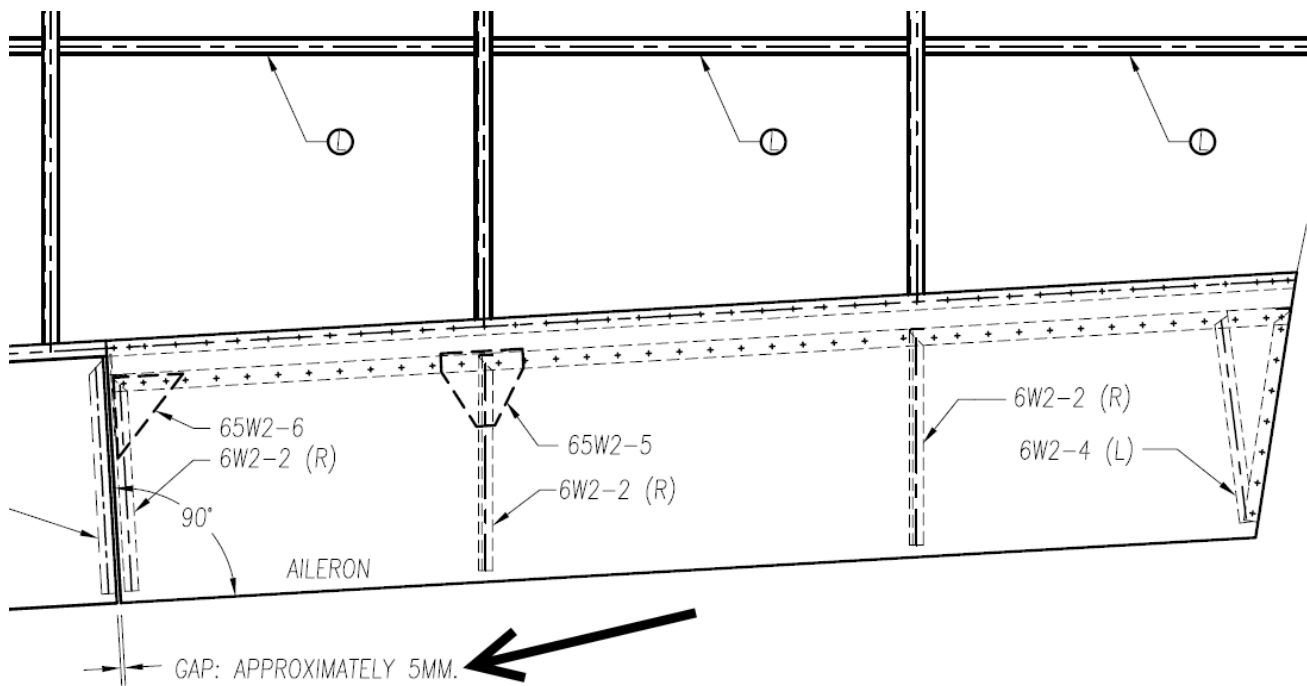
GAP: APPROXIMATELY 5MM. ←
 CHECK: AILERON BOLT DOES NOT TOUCH FLAP.
 IF NECESSARY, MOVE AILERON OUT TO INCREASE GAP TO MAINTAIN SUFFICIENT DISTANCE
 BETWEEN HEAD OF AN5 BOLT THROUGH HORN 6W2-1 AND FLAP: REF. 6-W-10

Above is from the Zodiac 650 drawings. A 5mm gap (about 3/16") is recommended between the aileron and the flap.
