SERVICE LETTER / NOTIFICATION – OCT 22, 2024

Seat back tube inspection and reinforcement

CH 750 – STOL / CRUZER / SD

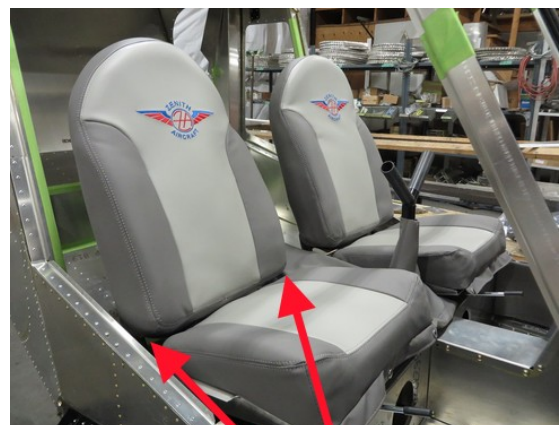
Some seat back steel tubs (C75F13-4) at the bottom have shown signs of damage. Applying an excessive amount of breaking force will result in a huge amount of pressure on the seat back, and this can damage the tube.

Seatback tube damage

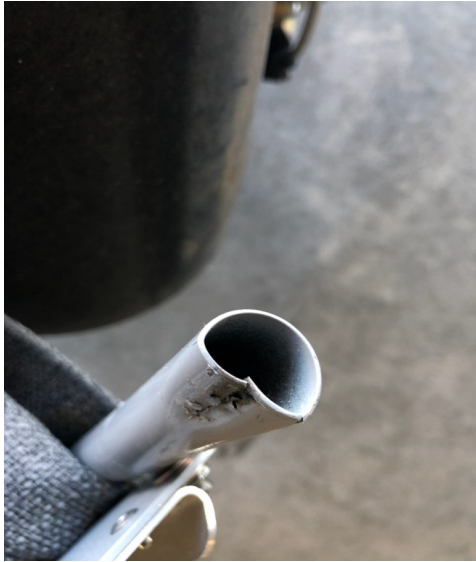
Typical damaged seat back tube, at the bottom.

Inspect the seat back bottom area on both seats. Also, its an opportunity to inspect the general areas of the seat. Check the welded pins on the seat back, to make sure that the tube at the weld has not cracked, check the rivets around the seat pan etc. Also inspect the welded rudder pedals tubing and area for cracks / damage. This is a simple and quick inspection.
