SERVICE LETTER August 11, 2020

Inspection of aileron root rib, left and right wings

The affected models are aircraft CH 2000 serial numbers 20-0002 and up.

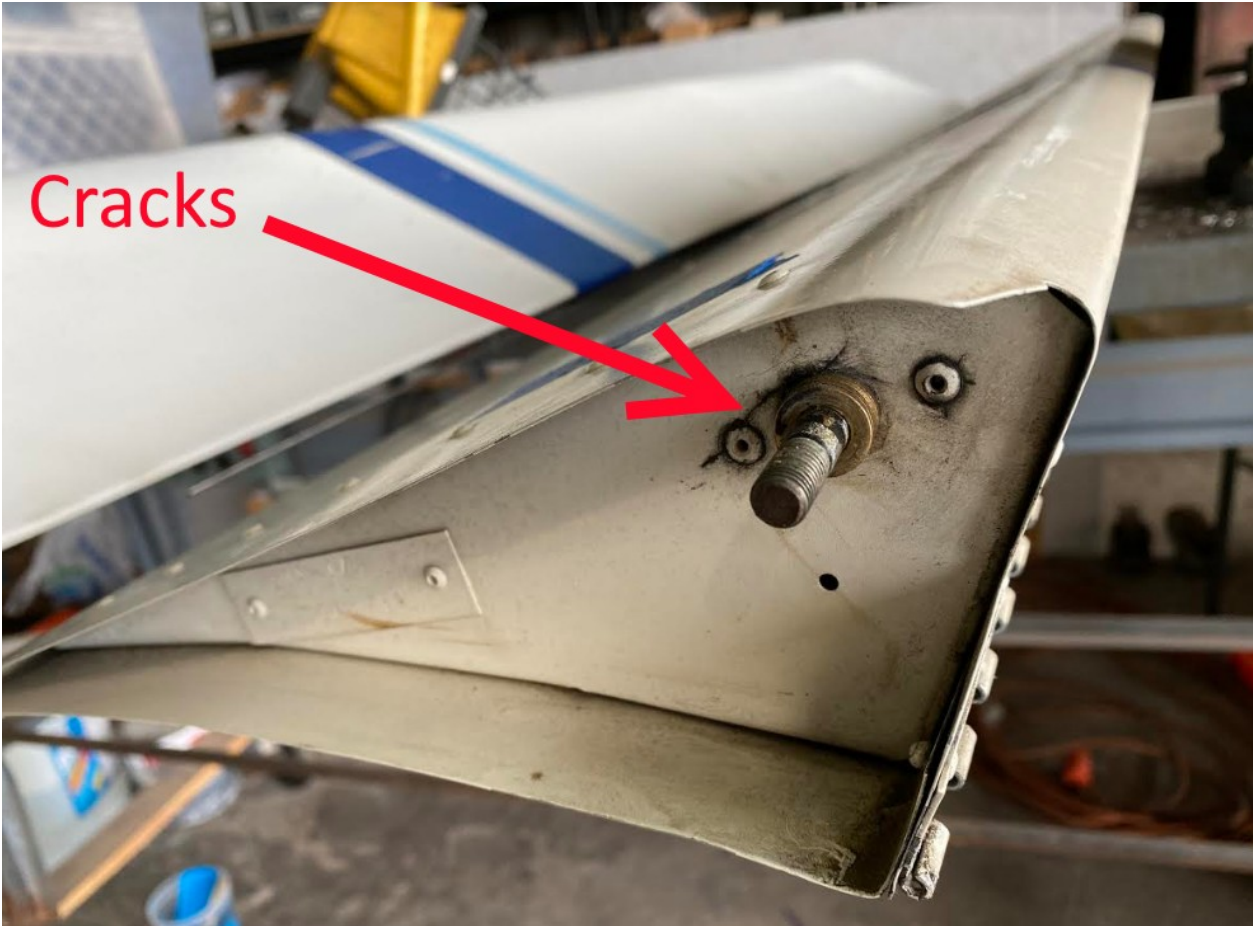
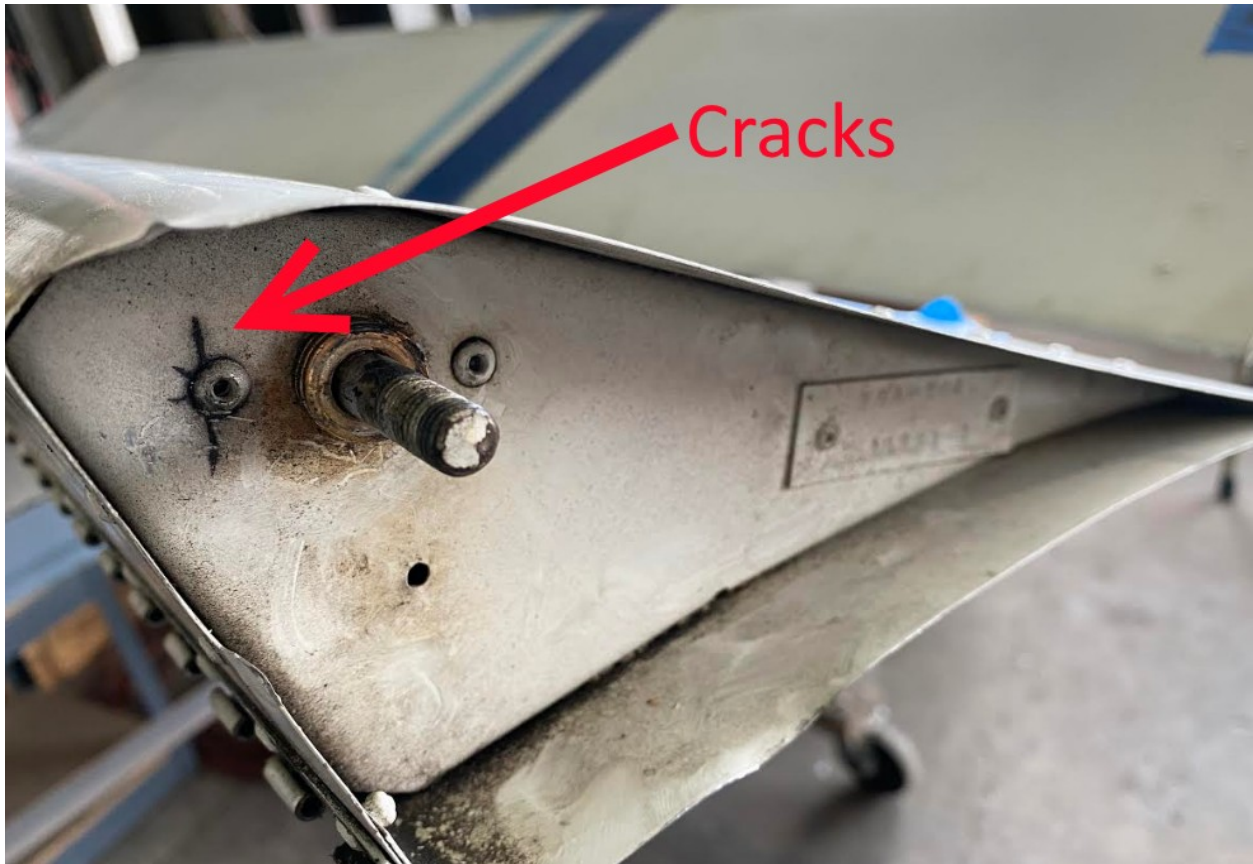
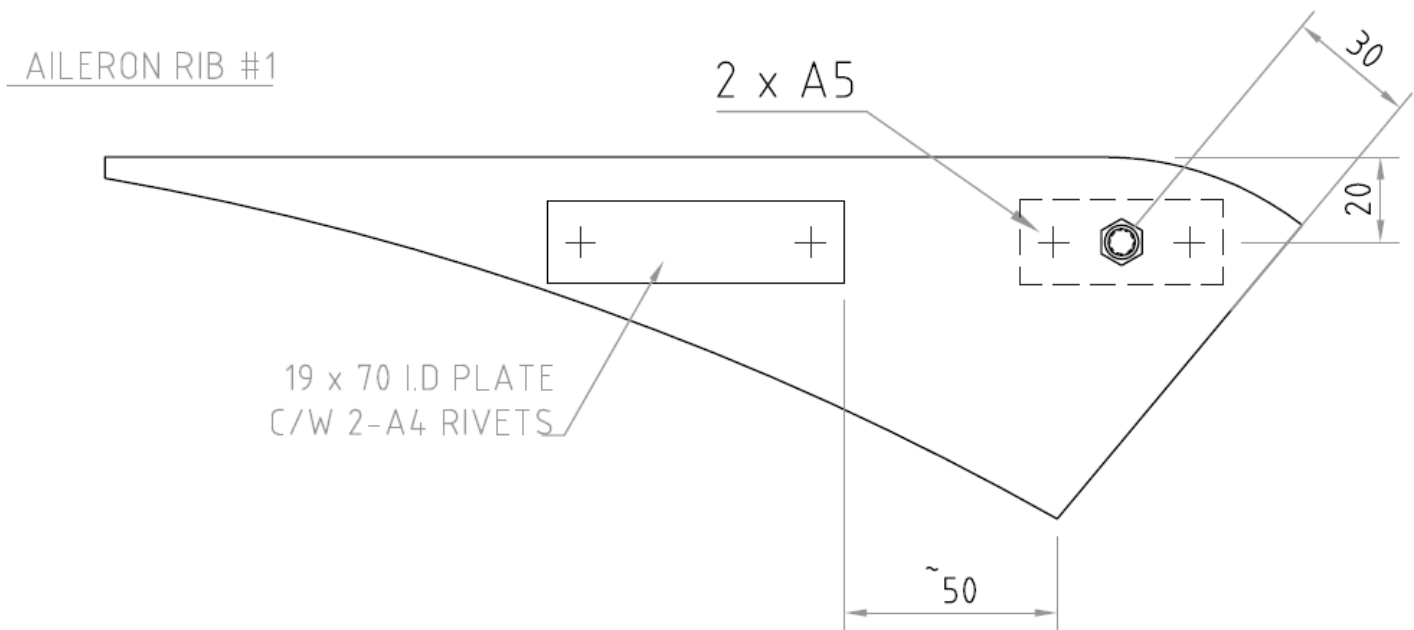
A CH2000 customer noticed cracks in his aileron root ribs as per the following photos.

If cracks are present, remove the root rib and replace Part number 20-A-1-1. Use the cracked rib to copy the pin hole location to the new rib. Use A5 rivets (5/32" dia Zenair rivets) to install. See the Service Manual. Or, fix the existing rib(s). Use AC-43.13-1B page 4-32.

Once completed, perform a full inspection of the aileron system including the cable tensions.
