SERVICE LETTER / NOTIFICATION – OCT 28, 2024

Nose wheel strut inspection / update

CH 801 series

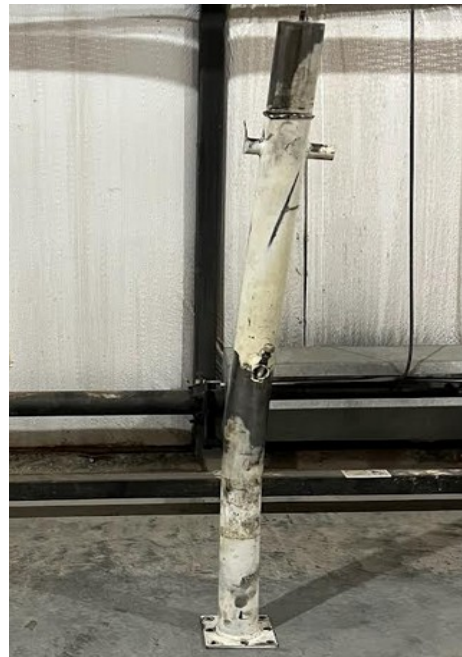
This has worked out well over the years. However, when doing a hard nose landing or when taxiing at high speeds on rough surfaces, it's possible that the strut tube could start to bend.

Bent nose wheel strut.

In the event that there is slight bending or wearing of the nose wheel strut steel tube, it must be replaced before the next flight. When replacing, purchase a new one from Zenith Aircraft Co. The wall thickness of the new strut is thicker at 1/8" (0.125").
